Navajo Abandoned Uranium Mine

Site Screen Report

Mine Name: Firelight No. 6
Mine ID: 513

Navajo AUM North Central Region

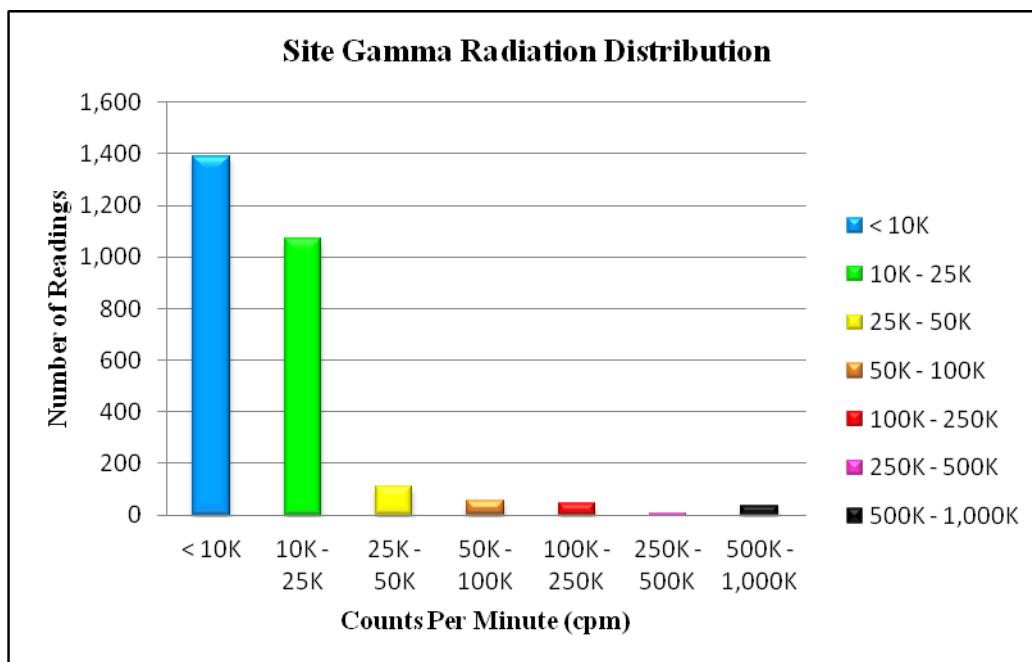
Distribution Chart and Statistics:

Site Gamma Radiation Statistics

Number of Readings	2,715
Minimum (cpm)	5,931
Maximum (cpm)	999,960
Mean (cpm)	27,587
Median (cpm)	9,874
Standard Deviation	105,353

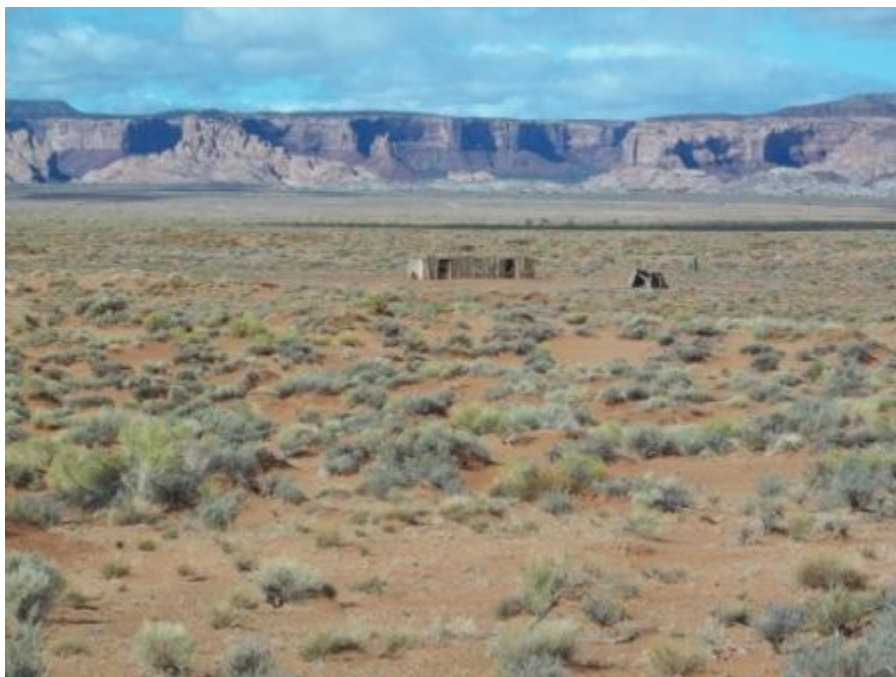
Photo 2

Mine Site #513 - Structures

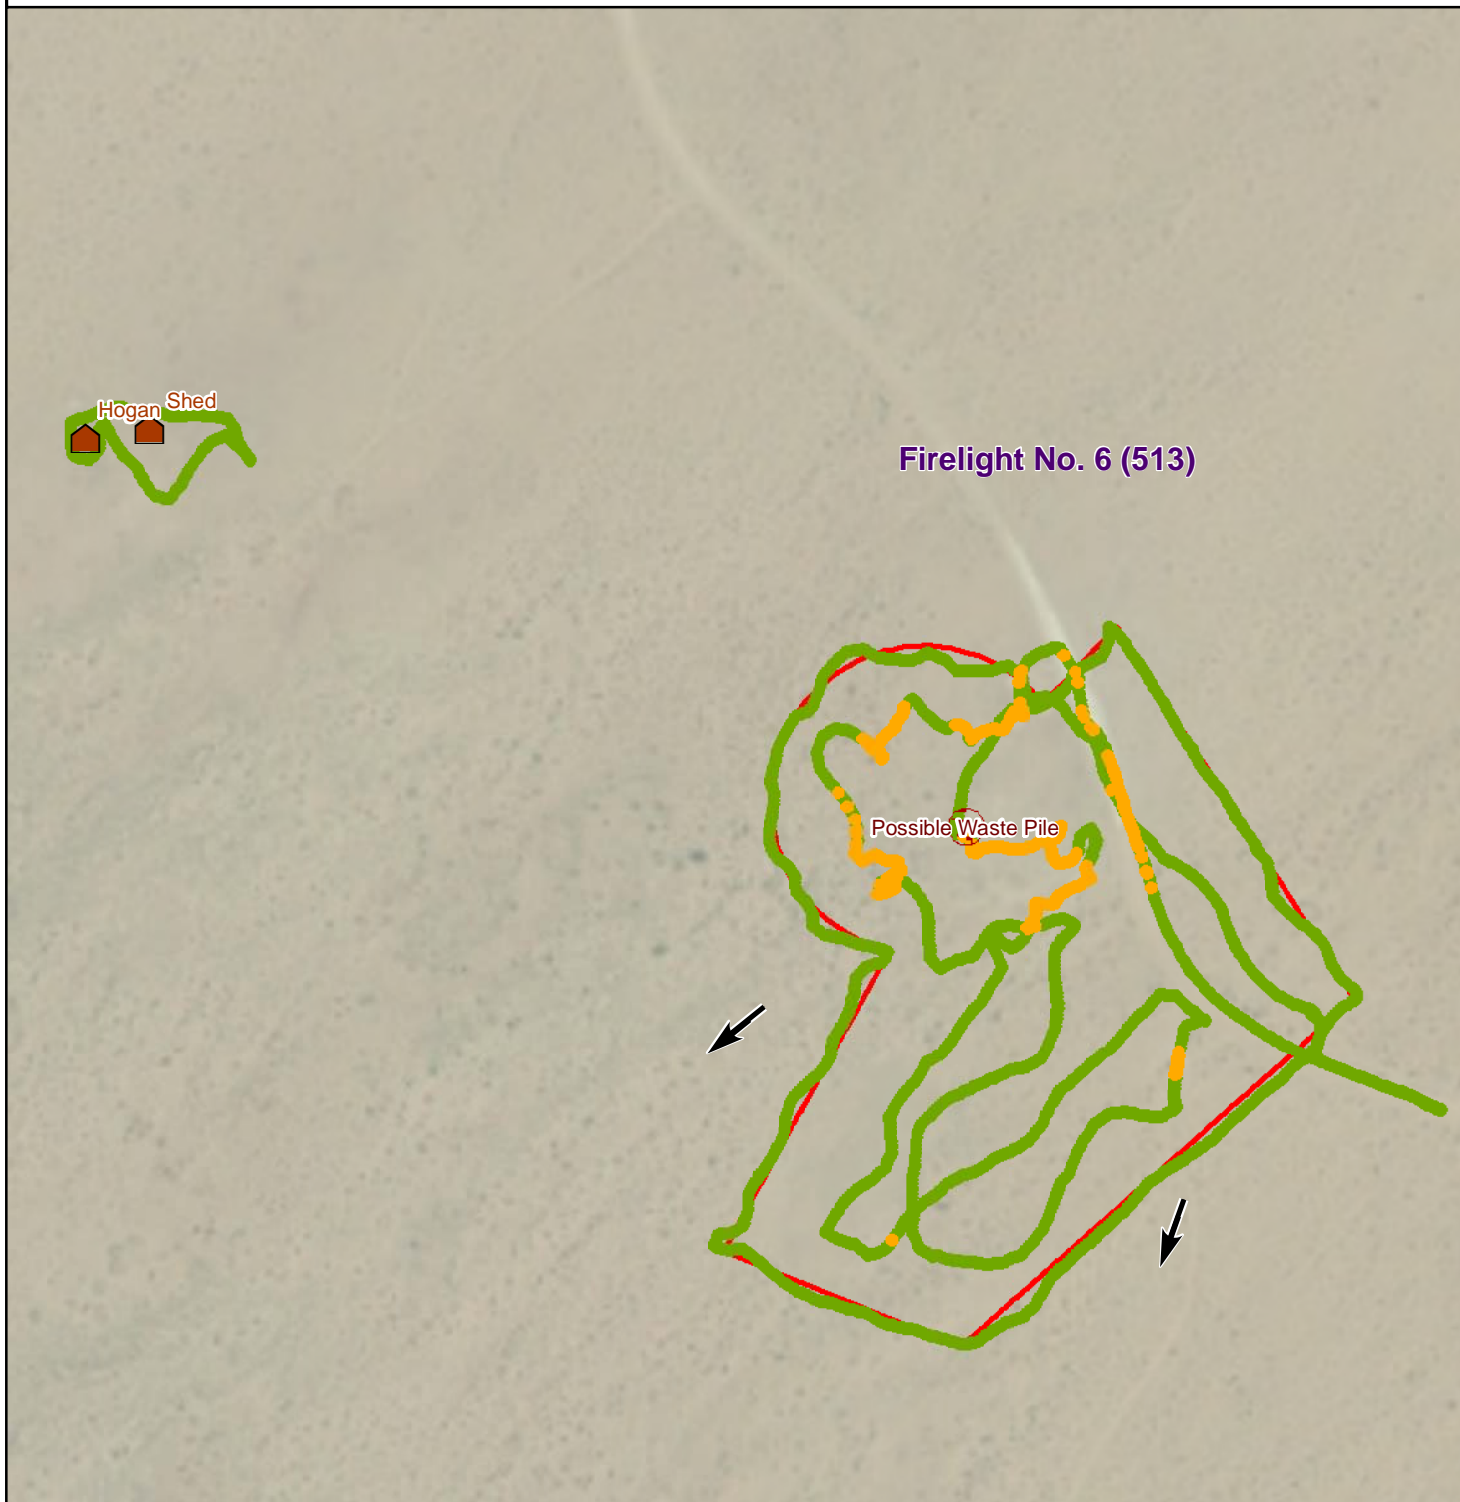
**Figure 1 - Gamma Radiation Measurements, Above Two Times Background
Firelight No. 6 (513)
Oljato Chapter, Navajo Nation**

Gamma Radiation Measurements

- < 2X Background
- > 2X Background

Measured as counts per minute (cpm)

Average background 8,883 cpm

A total of 2,715 gamma radiation measurements were collected from the mine site, ranging from 5,931 cpm to 999,960 cpm. Maximum levels of approximately 1,000,000 cpm were found near the dunes, and 50,000 cpm alongside the roads. The measurements are represented in Figures 1 and 2.

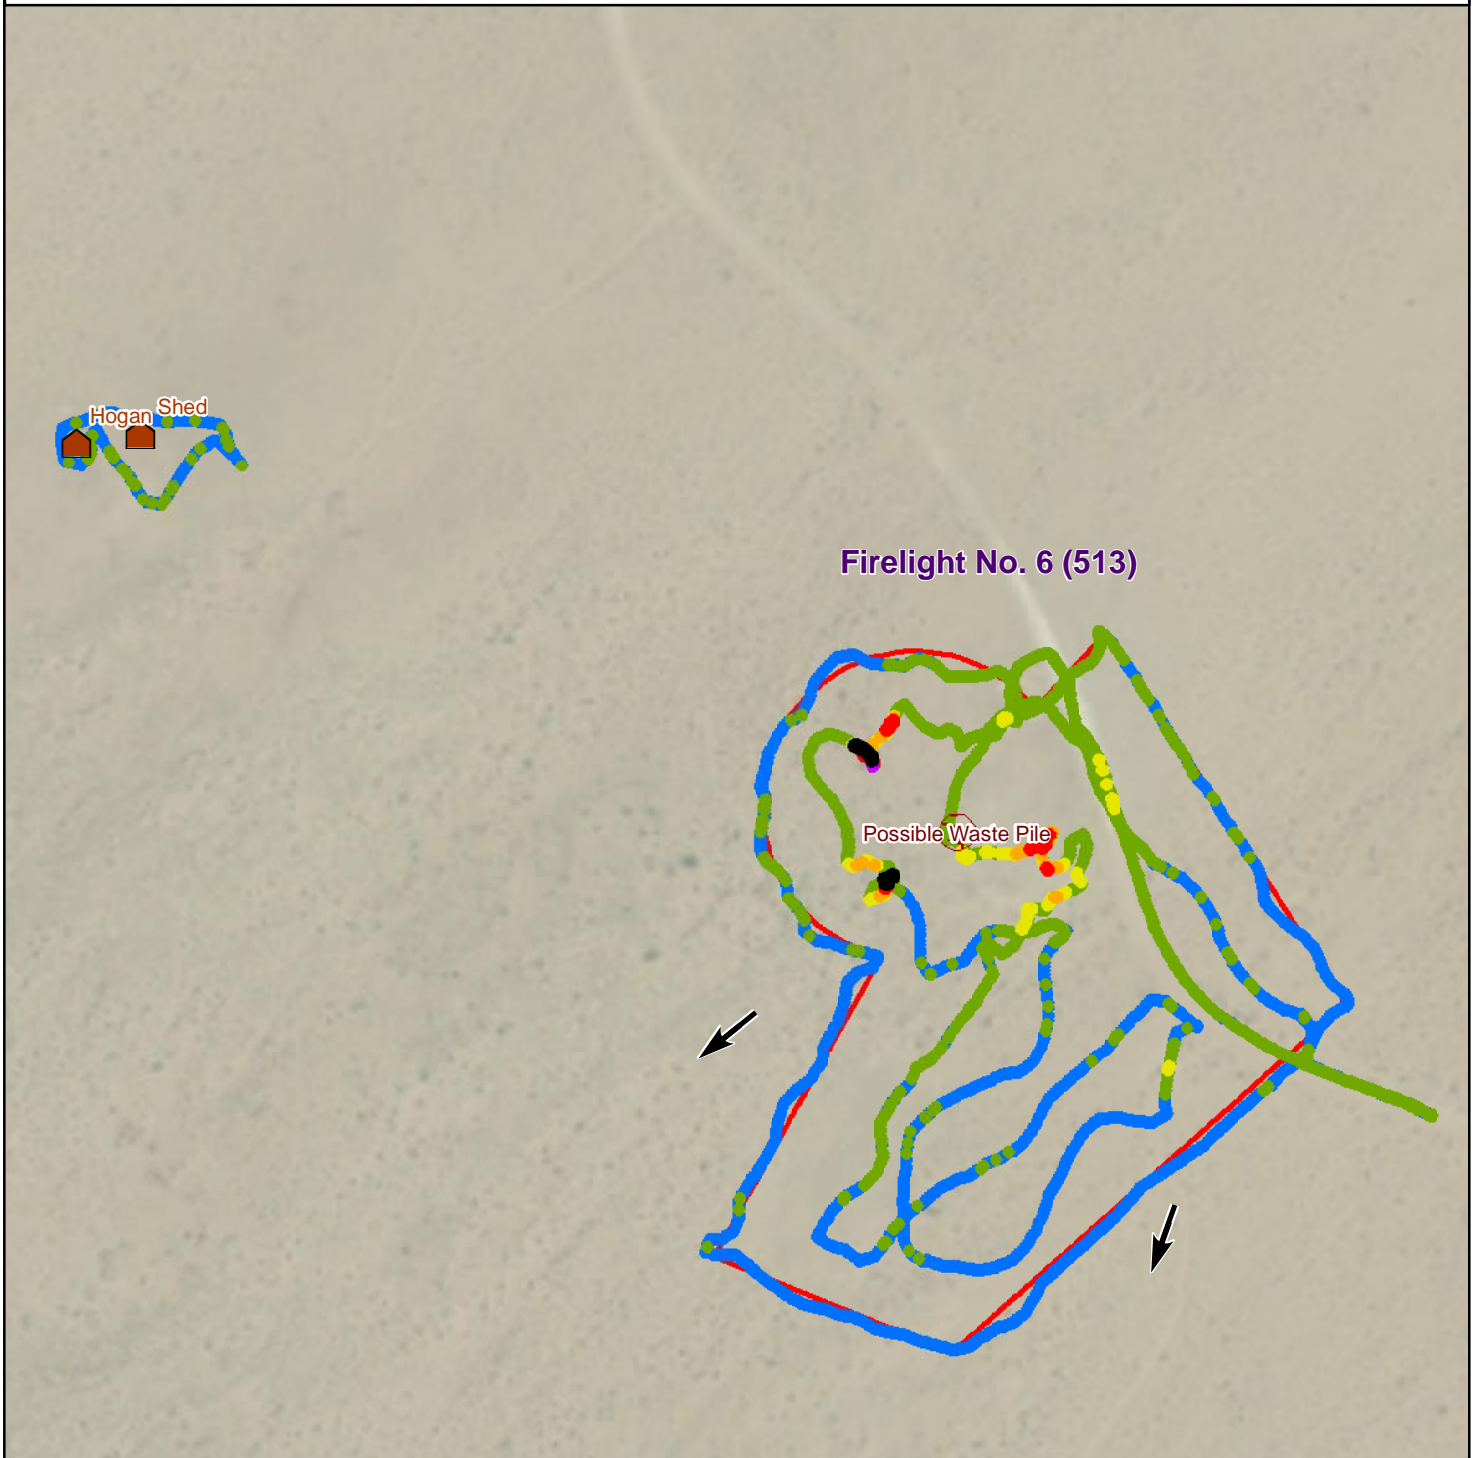
**Figure 2 - Gamma Radiation Measurements
Firelight No. 6 (513)
Oljato Chapter, Navajo Nation**

Gamma Radiation Measurements

- 0 - 10,000 cpm
- 10,000 - 25,000 cpm
- 25,000 - 50,000 cpm
- 50,000 - 100,000 cpm
- 100,000 - 250,000 cpm
- 250,000 - 500,000 cpm
- 500,000 - 1,000,000 cpm

Average background 8,883 cpm

Measured as counts per minute (cpm)
